## FORMATION, MOVEMENT, AND RESTORATION OF DEAD INTERTIDAL OYSTER REEFS IN CANAVERAL NATIONAL SEASHORE AND MOSQUITO LAGOON, FLORIDA

STEPHANIE K. GARVIS,\* PAUL E. SACKS AND LINDA J. WALTERS

Department of Biology, University of Central Florida, 4000 Central Florida Boulevard, Orlando, FL 32816-2386

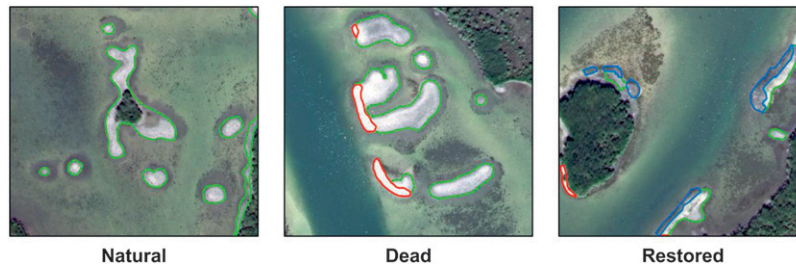
**Figure 2.** Three reef signatures used to identify reef types during photointerpretation. Natural reefs are outlined in green (left), dead reefs are outlined in red (center), and restored reefs are outlined in blue (right).

During preliminary field checking in the summer of 2010, unique reef signatures were developed for the three reef types: natural, dead, and restored (Fig. 2). Natural oyster reefs were identified based on the following criteria: globular or irregular in shape, with dark margins around the edge of the reef, and a lighter color in the center of the reef. Dead reefs were identified based on the following criteria: bright white reflection due to bleached, disarticulated shells that were continuously exposed, even at high tide. Dead reefs were found either adjacent to existing natural oyster reefs or standing alone, typically located on main boating channels (Fig. 3). Locations of all restored reefs were known before digitizing. Restored reefs were identified based on the following criteria: a more rectangular shape compared with the globular shape of the natural reefs.

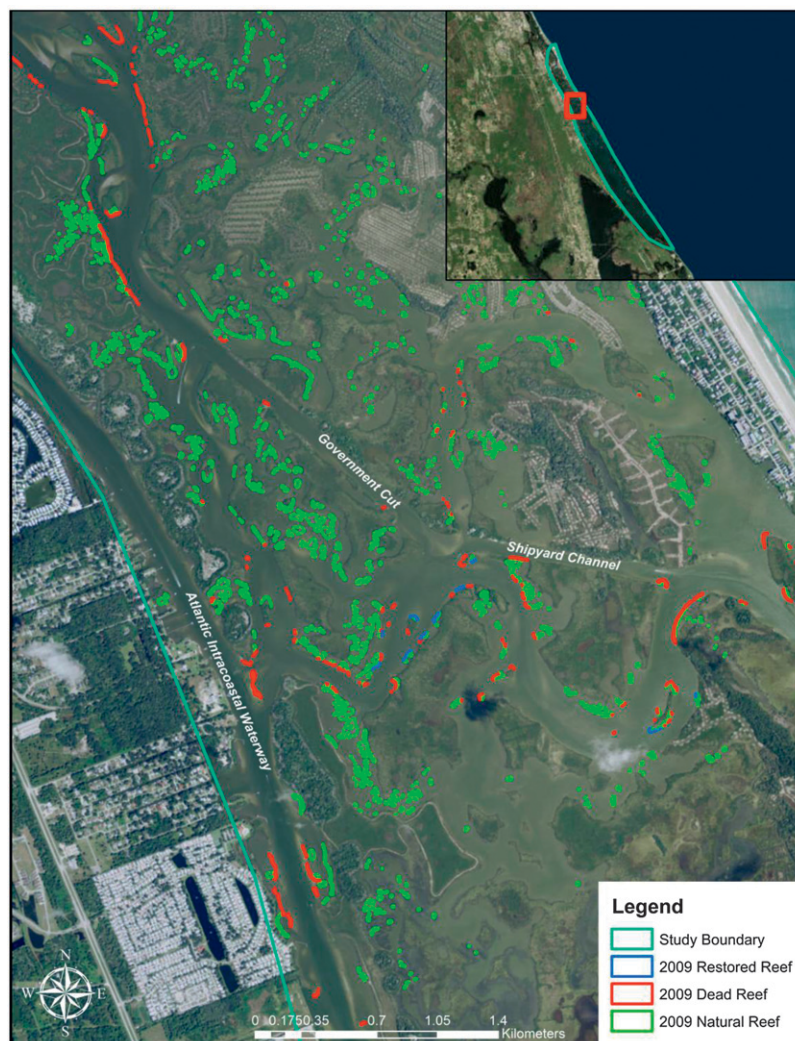
**Figure 3.** A selected portion of ML oyster reef coverage in 2009 (enlarged for visibility). Green represents natural reefs, red represents dead reefs, and blue represents restored reefs as of 2009. The inset shows the location of the selected portion of the study area (red) and the full extent of the study area (teal).

After reef signatures were developed, aerial photography of ML in 2009 was digitized to identify different reef types (Fig. 3). A total of 2,542 natural reefs were identified (Table 2). Natural reefs ranged in size from <10 to over 5,000 m<sup>2</sup> and composed
